Inspection Report

Report Sample

Property Address:
1234 Your Street
Somewere NJ 08201

Peace of Mind Home Inspections

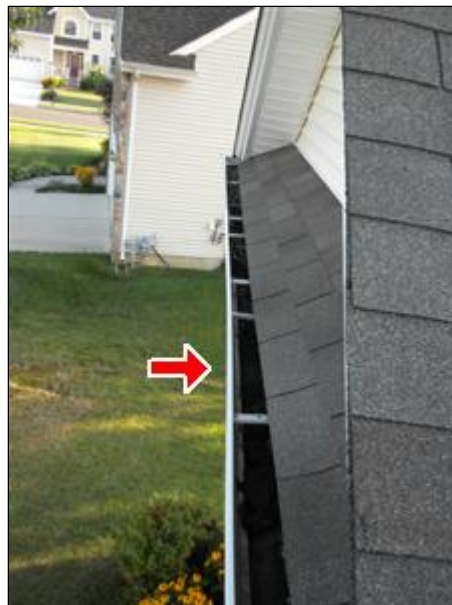
1.3 Picture 1

1.3 Downspouts need to be extended. Rain water can splash on home and cause water related problems. Recommend extending spouts to directly above splash blocks.

Gutters have leaf debris. Clogged gutters will not properly drain which can cause ice damming in the winter which could result in water damage to the home.

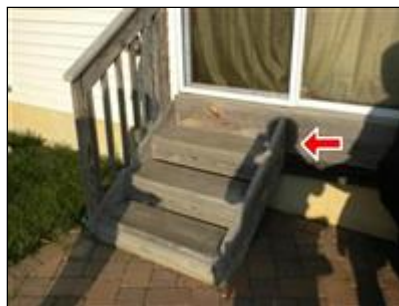
2.3 Picture 1

2.3 The front concrete steps have settled and developed a crack at the front stoop. Recommend patching

The rear wood steps are not attached securely to the home. No hand rail on right side of steps. Recommend repair by a qualified contractor for safety.

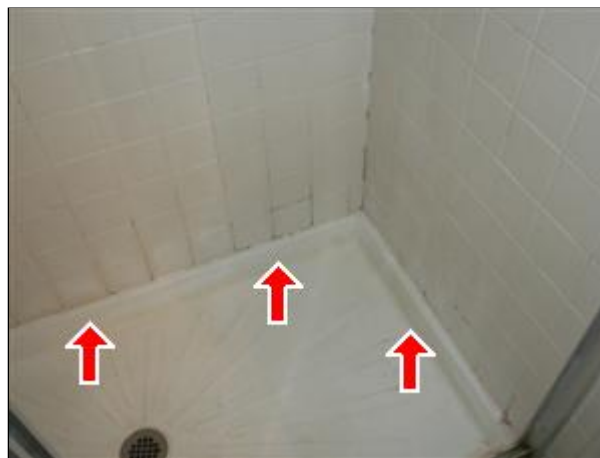
4.1 Picture 1

4.1 Tile surround master bath is missing grout and not secure. Wall framing and wall board may have been impacted. Recommend repair by a qualified contractor

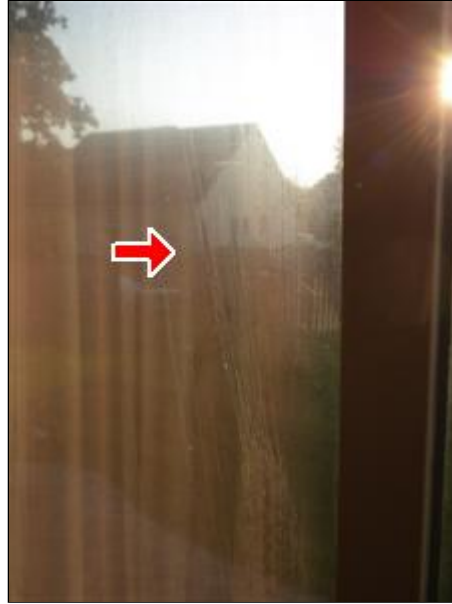
4.5 Picture 1

4.5 Kitchen sliding glass door has a broken seal which has allowed moisture to condense between the two panes of glass creating a cloudy look. Recommend replacement of the pane by a qualified contractor.

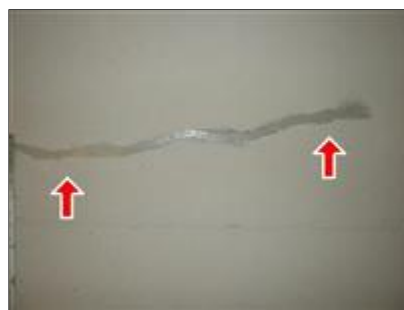
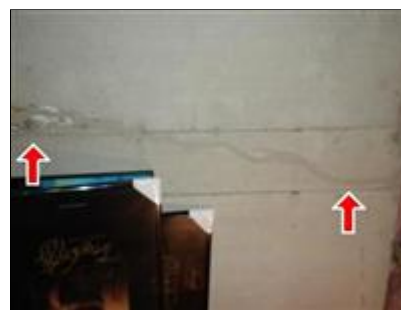
5.0 Picture 1

5.0 Small cracks on the foundation and in basement. These cracks have been sealed. Recommend monitoring for future movement
